In this article, Envirotek delves into a recent case of diesel-bug contamination in Queensland.

The vehicle was a 2005 Nissan Patrol. This 4WD had recently been purchased from North Queensland and been sitting for a while before the new owner started using it on a regular basis again.

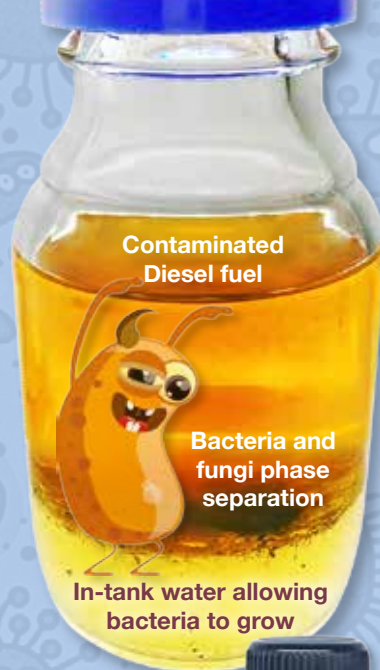
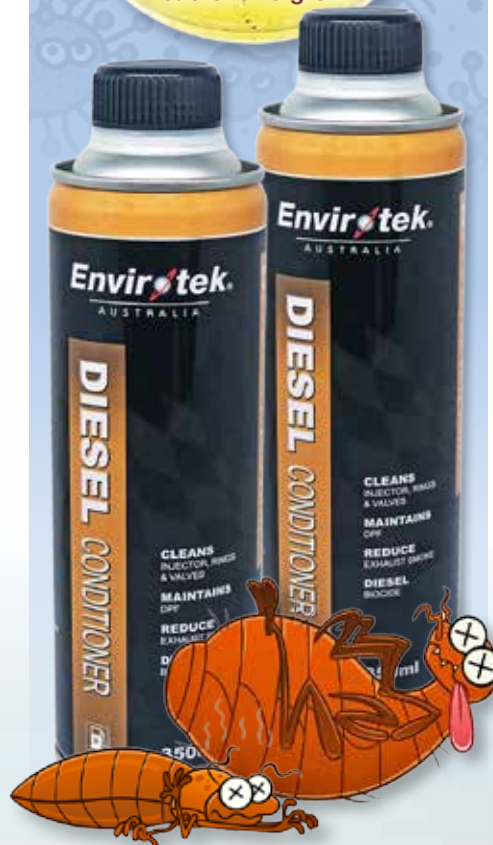
Diesel bug contamination

Diesel-bug contamination in the fuel tank grows and develops in the layer between diesel and water, where the micro-organisms break down the alkanes in the fuel using oxygen from the water.

This process multiplies and creates black sludge that forms in the fuel tank – this is what we identify as ‘diesel bug’. The sludge can grow at a rapid rate and block fuel filters, fuel lines and pick-ups, as well as creating adverse running conditions or even stopping the engine.

With the vehicle once again on the road, it started having problems. It broke down a few times before the diesel-bug issue was diagnosed.

The fuel tank was removed and cleaned with petrol until no sign of the bug was left, then the tank was reconnected and the car handed back to the customer.

In our experience what was done to eradicate the diesel bug was the correct process but they also needed to treat the entire fuel system with a powerful diesel biocide. Killing off every minute trace of the diesel bug is the only way to stop recontamination from happening again and again.

When the tank was cleaned the third time, they also added a 350mL shock treatment of Envirotek Diesel Conditioner, which contains a powerful biocide, to the new diesel fuel.

Furthermore, the vehicle's owner was also given a treatment of Envirotek EDC (Envirotek Diesel Cleaner) to dose the tank when filling up with diesel from service stations.

EDC is used as an in-tank treatment at ratio of 1:1000 to kill off remaining diesel bug in the fuel system (75L tank equals 75mL of product).
